Outil se remorquage DEBOGGING TOOL

АЛАТА ЗА ВУЧУ АВИОНА AIRBUS SAS L5349 (98L09103001 100) ТЕСТ НА ЗАТЕЗАЊЕ

REPORT No 5001/15 OF THE MLG R/I TOOL 98V32104000, Ser. No KLK04222 START-UP TEST

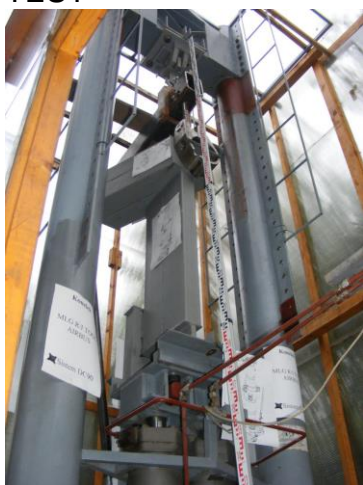
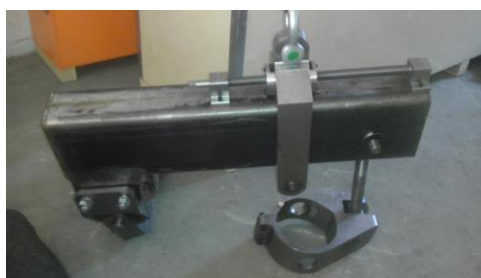
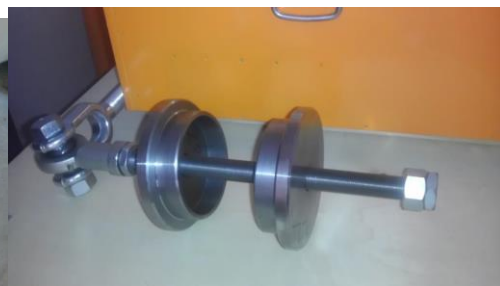
The test object view after the test Elements of the test article view

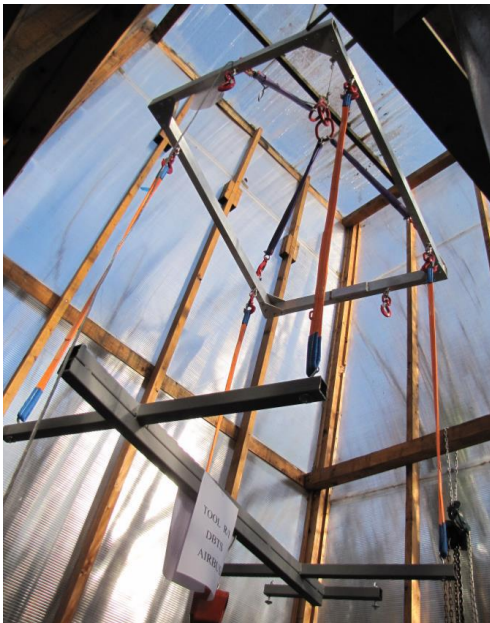
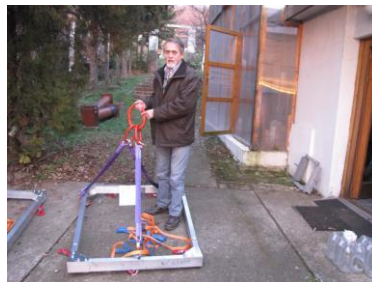
Test set-up in the RADOM configuration.

S/No KLK 6119 view after finishing all the tests . Load Test Scheme,

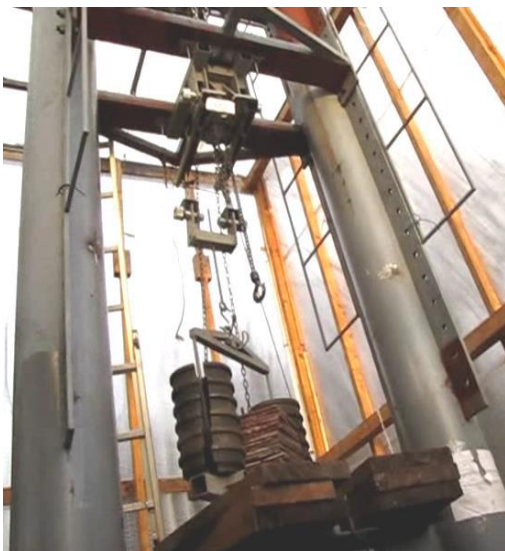
The 040 RAIL SYSTEM 1 test set-up

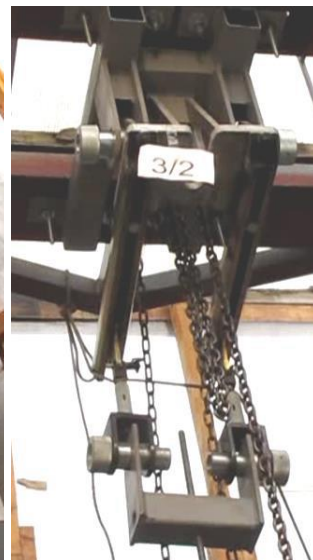
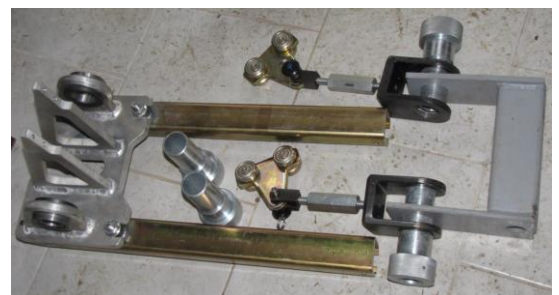
Test object 040 RAIL SYSTEM 1 view after the test

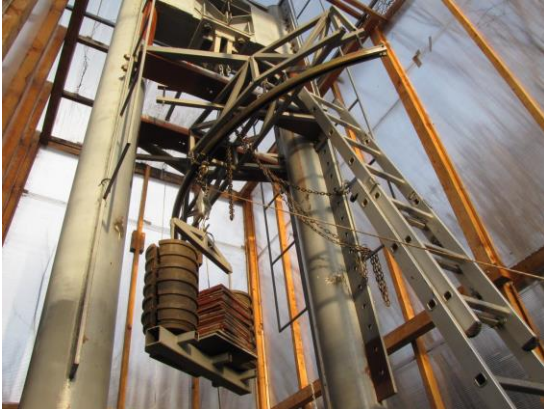
*Test set-up of the 042 RAIL SYSTEM 2*

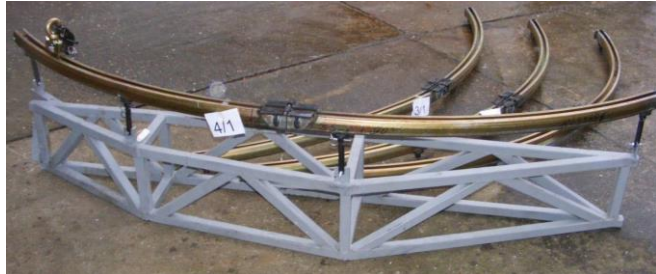
*Test object view after finish the test.*

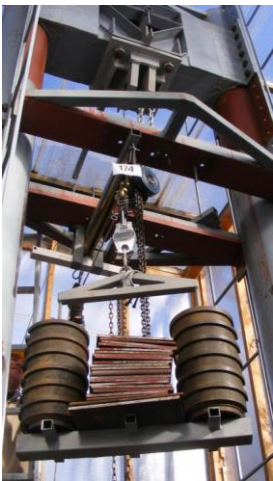
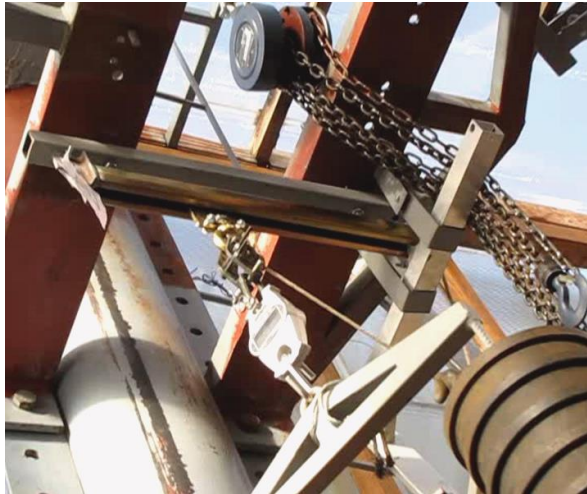
*Test set-up of the 044 RAIL SYSTEM 3*

*Test object view after finish the test*

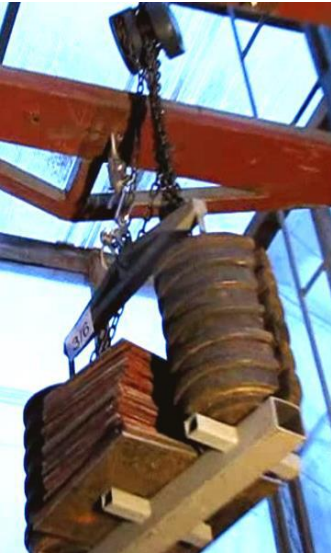
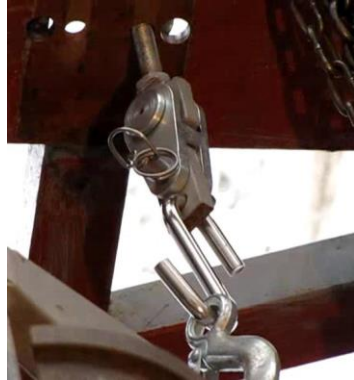
*Suspension and load introduction into the 046 ADAPTER*

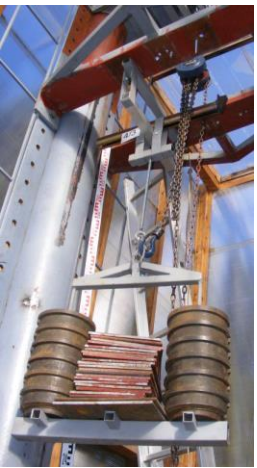
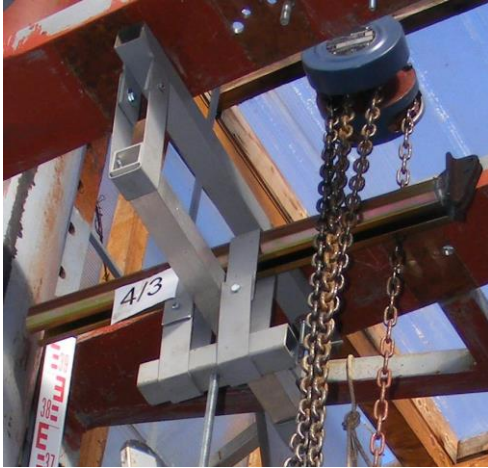
*Test set-up of the 050 TRAVERSE*

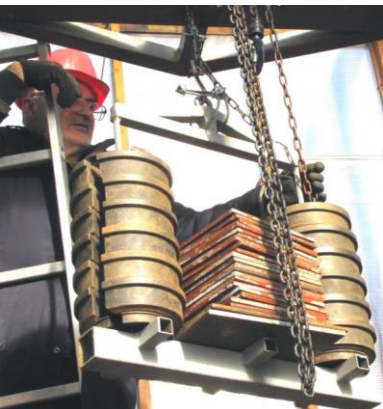
*Suspension and load introduction into the 118 CRANE TRACK*

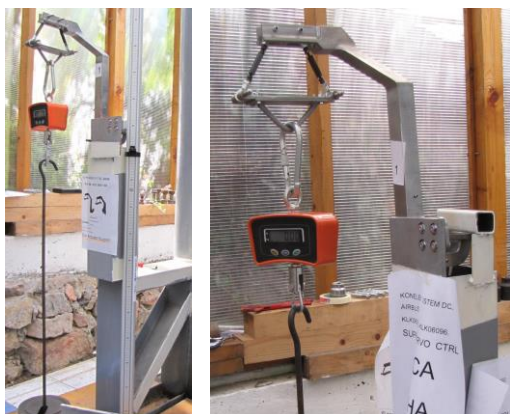
Test set-up view - Configuration 1 (EHA)

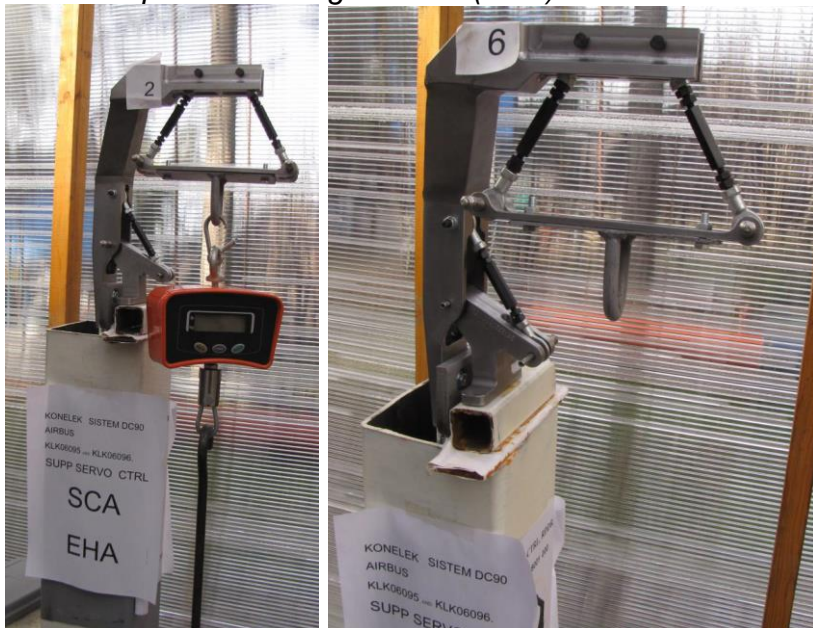
Test set-up view - Configuration 2 (SCA)

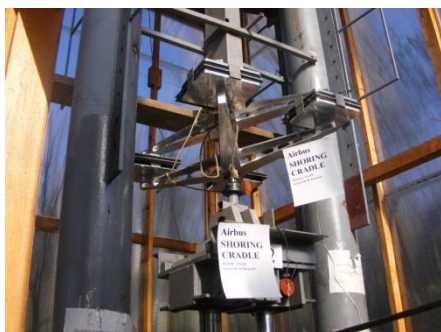
Test set-up view

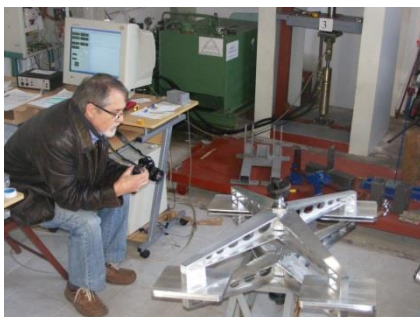
Delivered test articles view

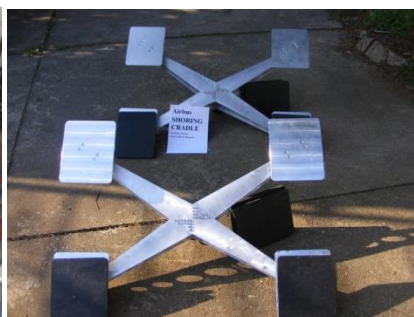
Delivered test articles view
